2013 Spanish Lake Vegetation Control Plan

LDWF, Inland Fisheries

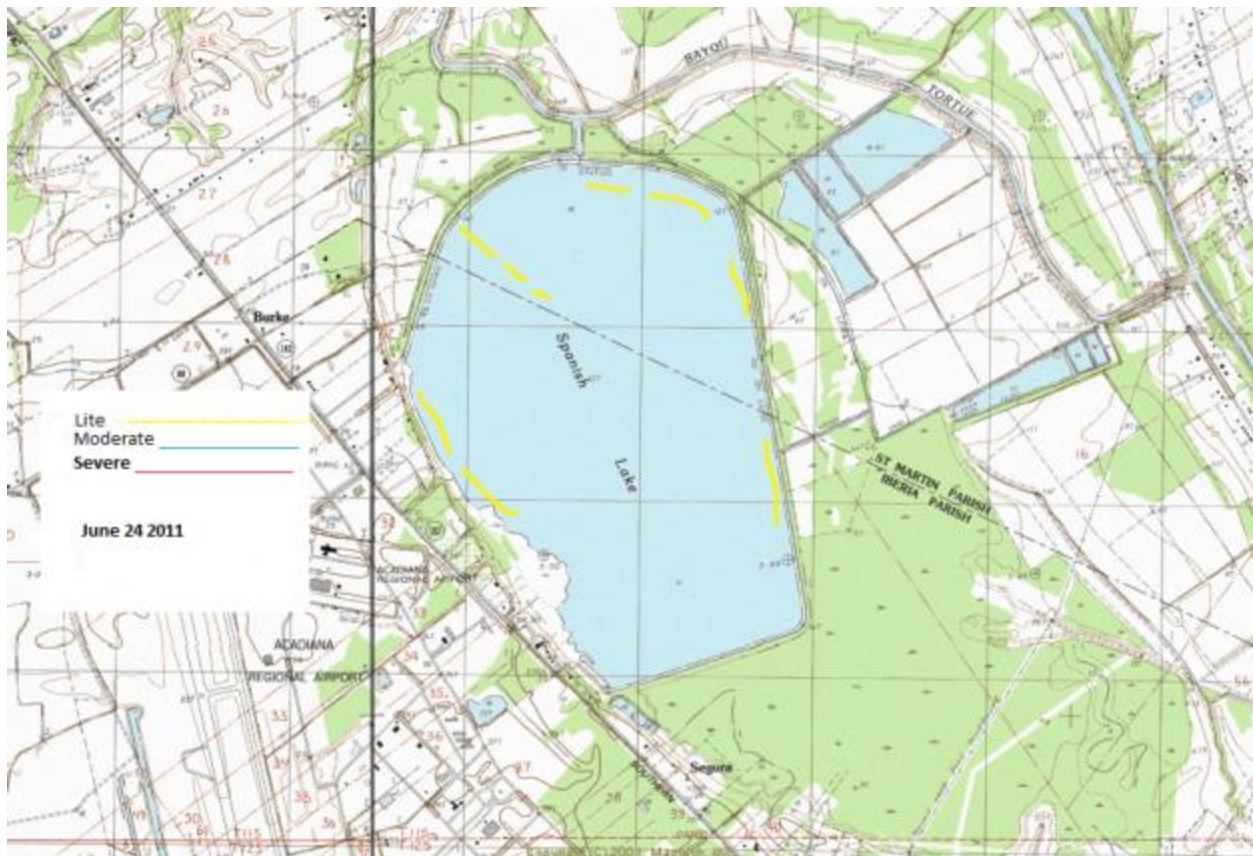
Spanish Lake Vegetation Survey 6-24-2011 - Martin Plonsky

A survey of aquatic vegetation found in Spanish Lake resulted in the conclusion that there is little to no aquatic vegetation in the lake. Very thin amounts of water hyacinth were observed in the vicinity of the boat launch and on the shoreline of the breakwater islands on the eastern side of the lake. The lake water was saturated ("bloom" condition) with planktonic algae and water pH was above 8.0. Small bunches of iris were seen growing along the eastern bank of the lake. Average water depth was 2 feet. The vegetation survey was conducted on the same day we investigated the report of a fish kill at the lake. No dead fish were observed.
